Removal of a well-stuck Myford chuck

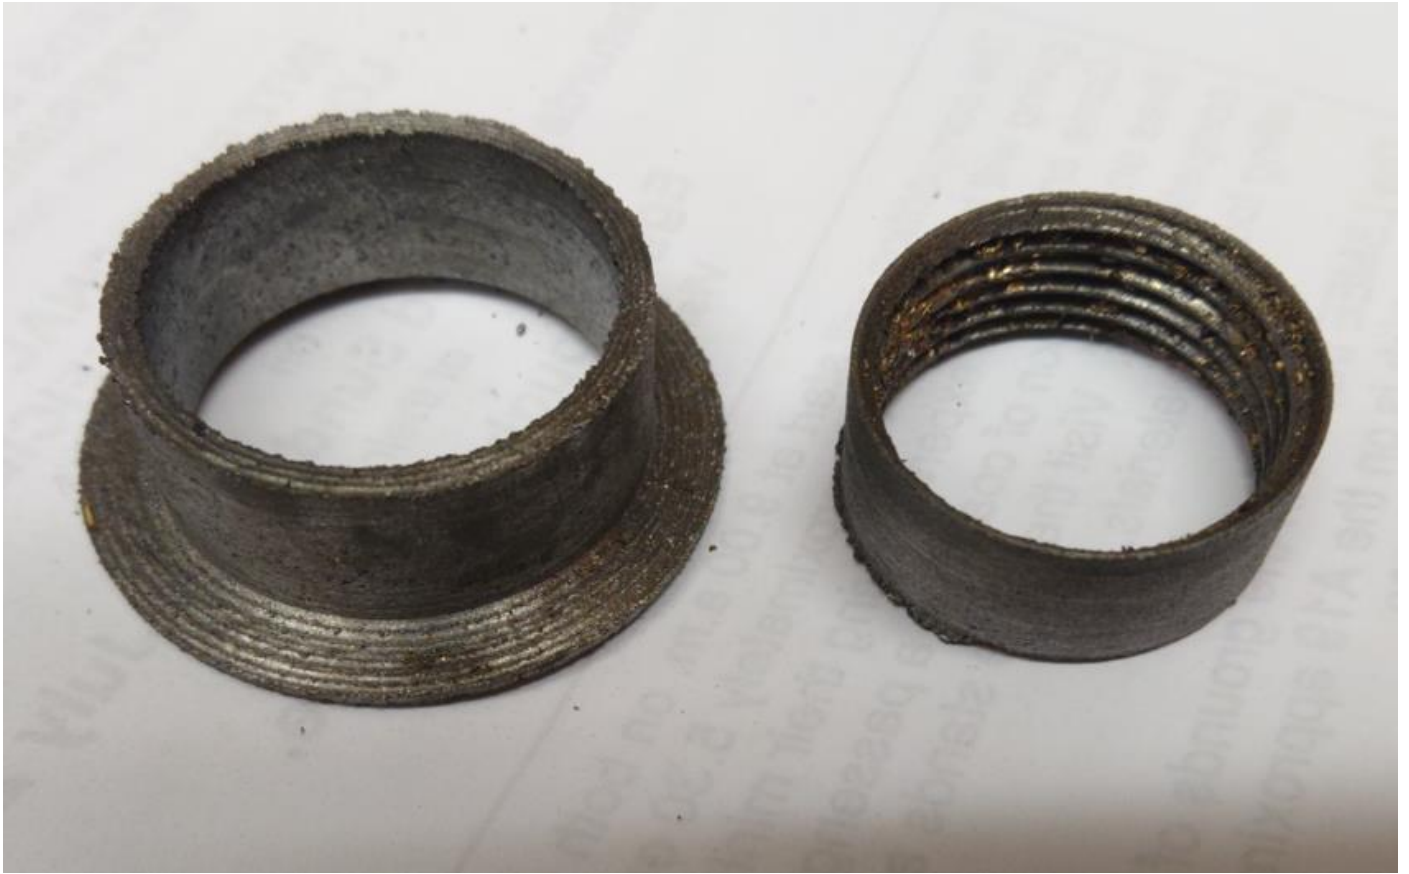
Nothing for it; we were going to have to sacrifice the chuck backplate. The chuck front was removed and the spindle plus backplate refitted to the lathe. A suitable carbide tool was then fitted at a very dodgy angle and at the extremes of carriage, topslide and cross-slide movements in order to get the tool to reach very near to the headstock casting – not something you need to do as a rule. Next step - turn away the backplate into a large pile of cast iron swarf. I ran the lathe backwards in the vain hope that it might actually unscrew itself during the operation. As the tool neared the hidden positions of the lathe spindle register and screw thread, care was taken to ensure it would not dig into the spindle. All of a sudden the remains of the backplate split into two; the front half simply unscrewed, leaving the larger diameter with the register bore in place – and that pulled off, revealing the unsullied spindle nose. Success! There was a certain amount of trapped brass swarf on the register face, and the screw threads had some traces of swarf on them, so that is what must have caused the problem – ***always ensure the chuck and spindle nose are scrupulously clean when fitting a chuck.***

The photo shows the sorry remains of what had once been a 4" diameter backplate:

A new backplate was ordered before the old one gave up the struggle...
