Virtual Work on the Table 04-Dec-20

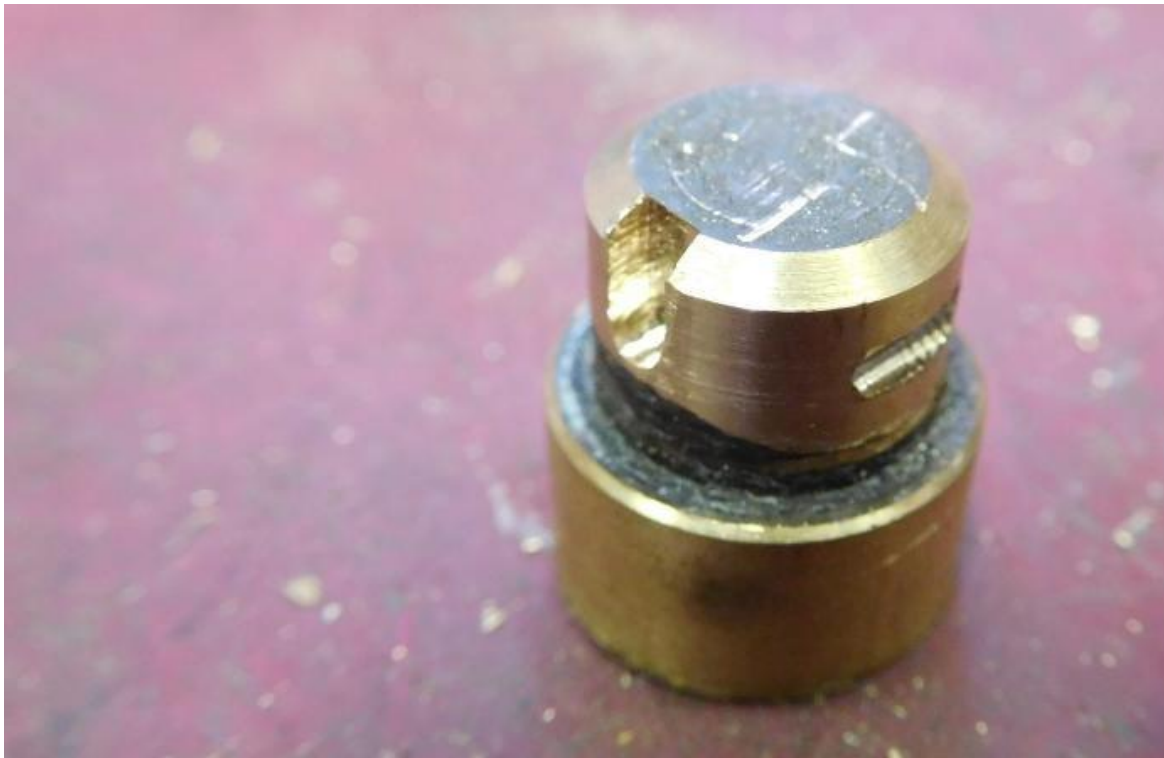
Here's the plug after use; you can see how awkward the M2 holes would have been to drill and tap, without supporting it with the plug:

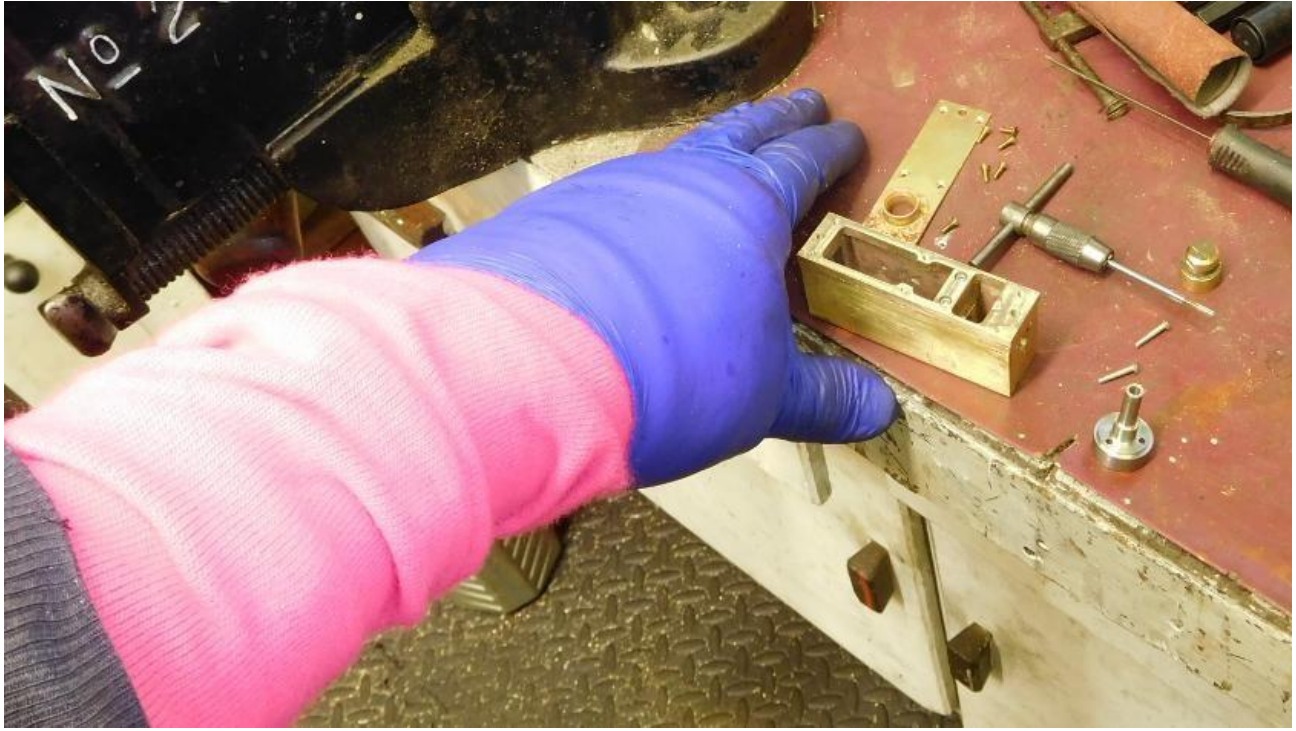
The insert was stamped to ensure it subsequently gets refitted the right way round; I was pleased I'd made the insert accurately enough so that it fits either way, but once the 1/8" hole was in place, there's probably only one right way now!

Job done! And all with a broken wrist...
