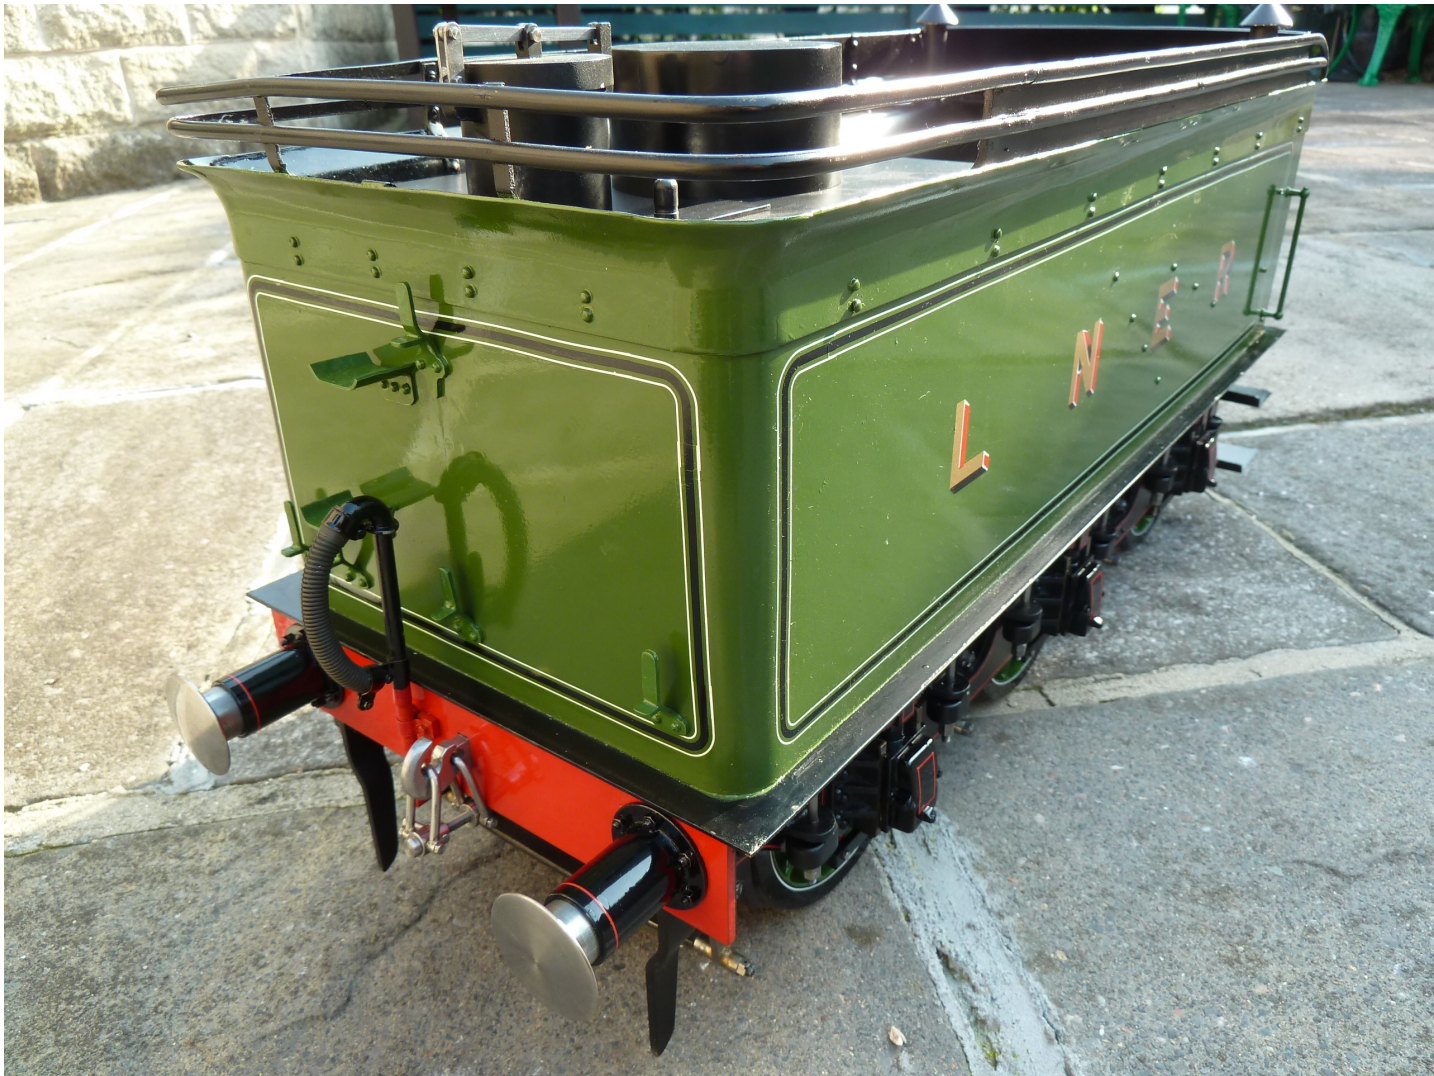
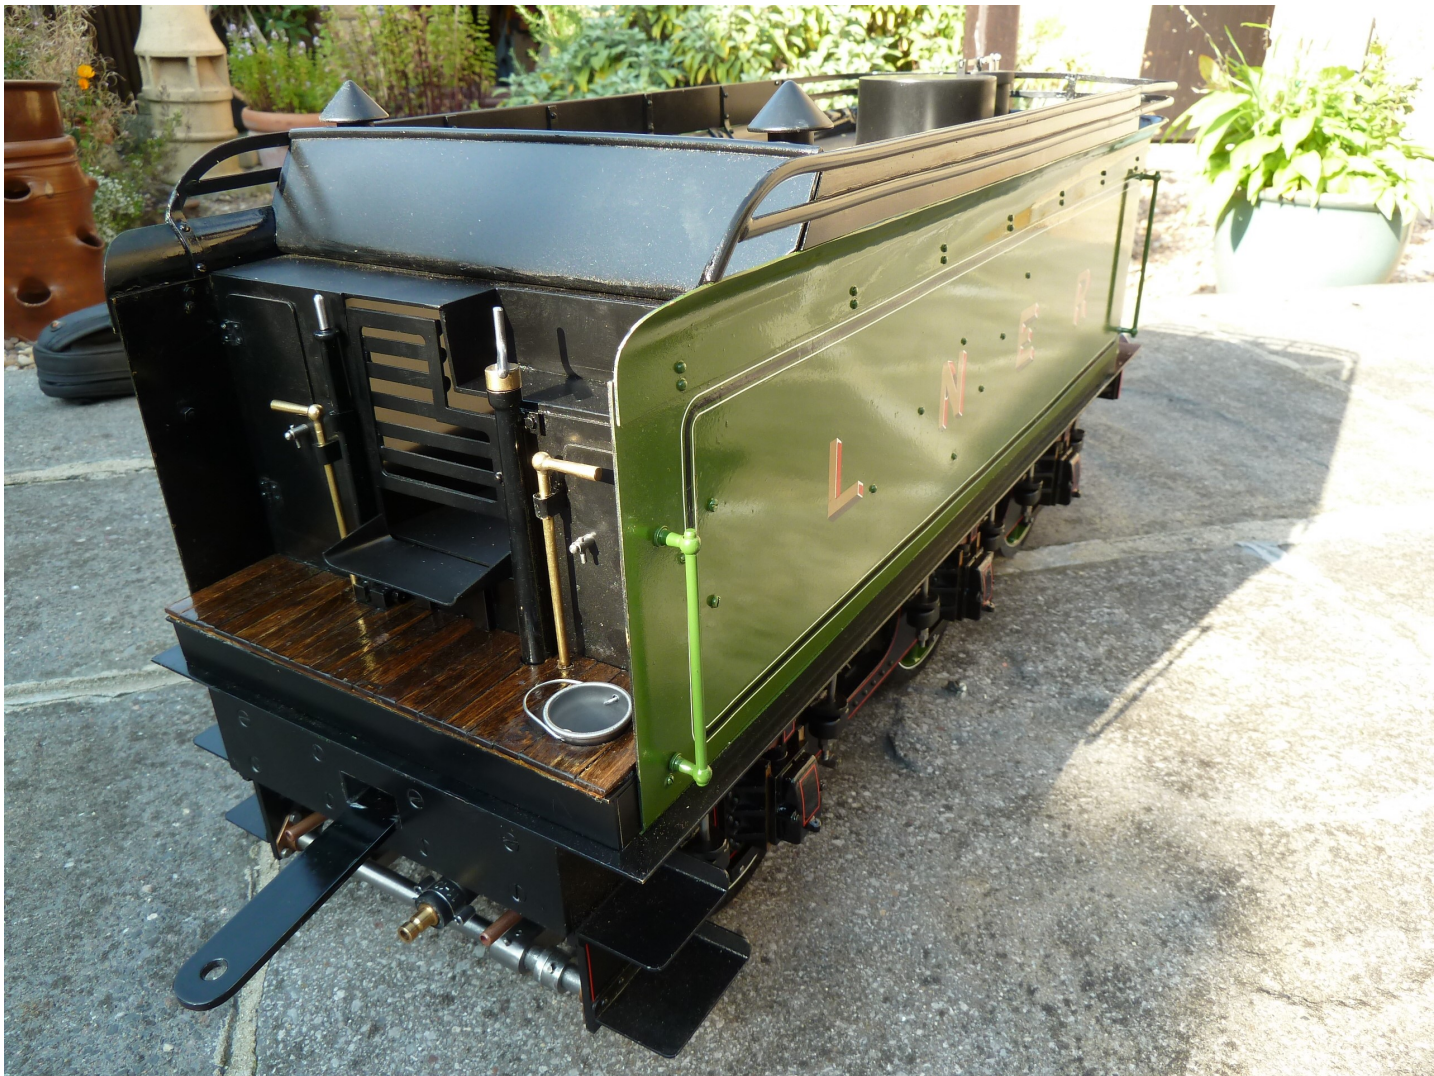
The lining out mainly used waterslide transfer sealed with a coat of clear varnish, the wooden coal floor is made from lolly pop sticks and the fireman's bucket was stolen from a dolls house! None has noticed yet but I fear repercussions someday. You should also be able to pick out two injector water feed valve handles, the axle pump quick release connector, the tender water scoop lever and a small tap for filling the bucket.

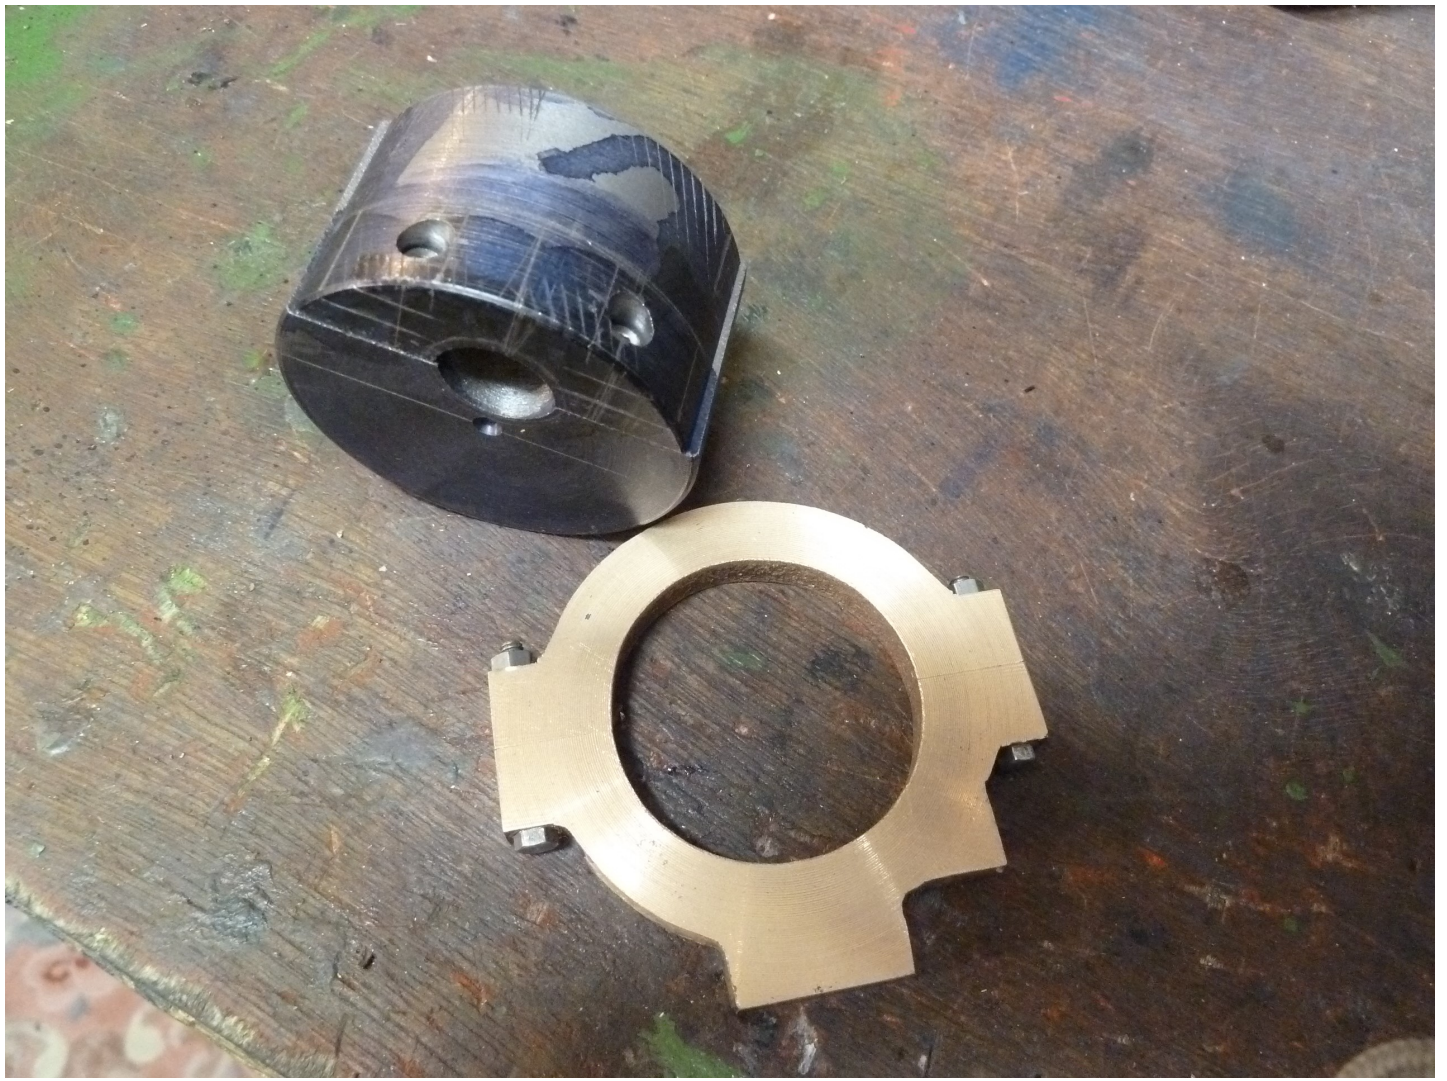
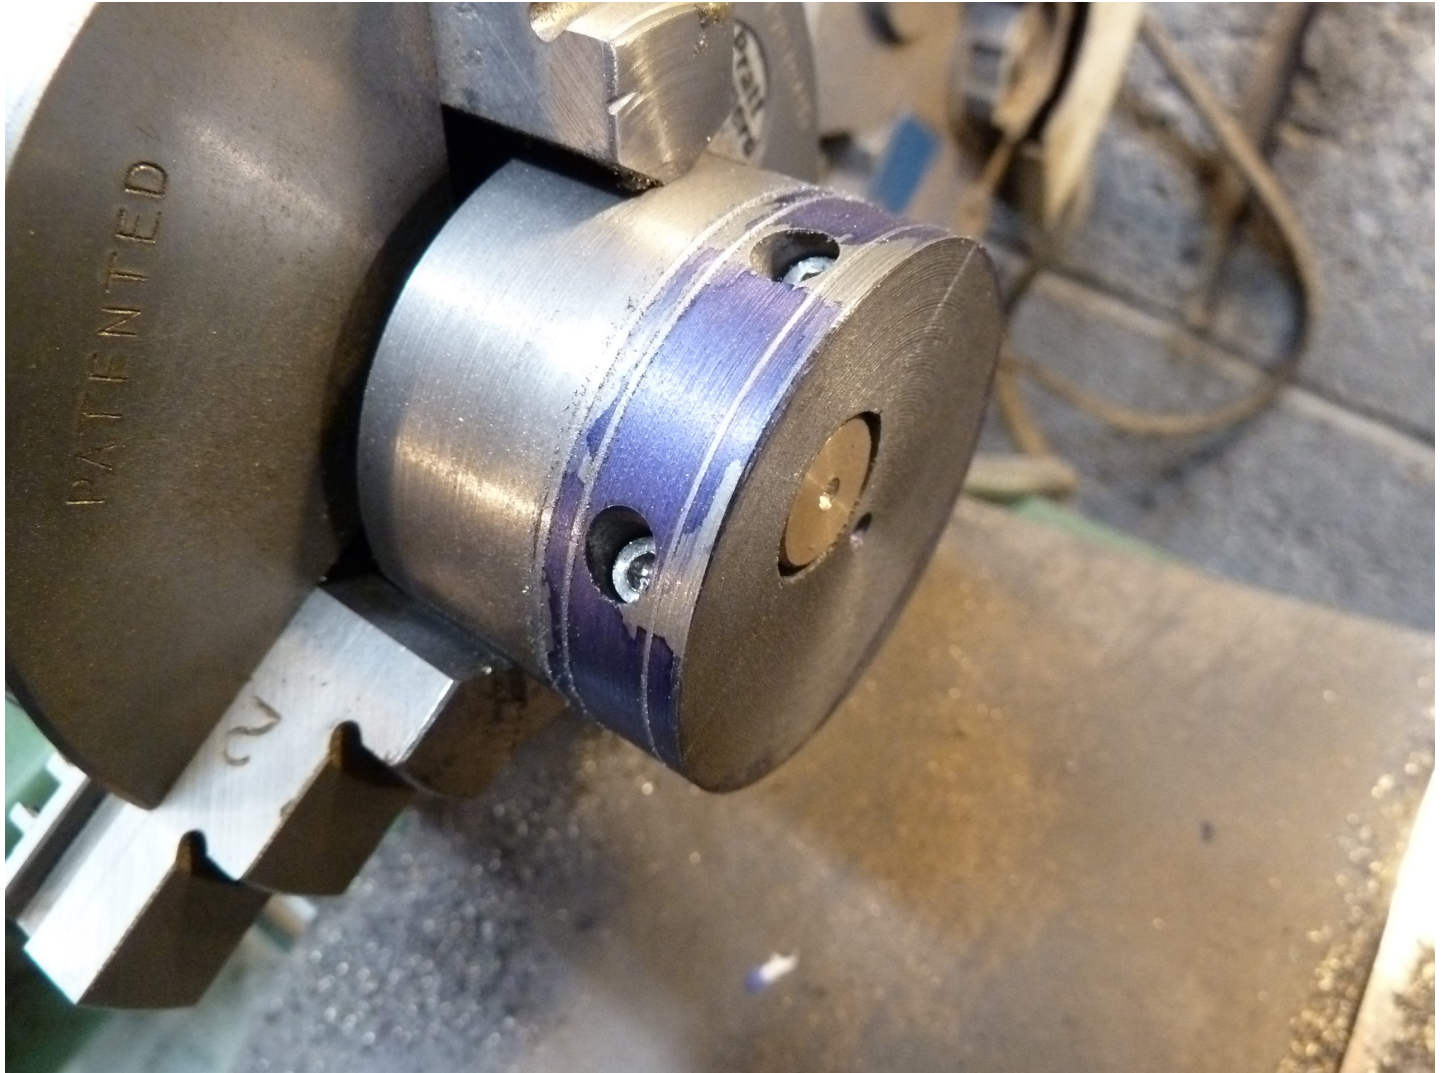
Another job I have done is to make a split eccentric to fit to the locomotive leading axle for a drive to a mechanical lubricator. The original idea was to use a displacement lubricator on this engine but the more I read about them the less I liked the idea. The main issue was that there was nowhere to fit a condensing coil and without one all the pundits said that reliability was poor. I don't recall having to make a split eccentric previously as any eccentrics needed were always fitted to the locomotive axle before putting on the wheels or the drive taken from the valve gear or piston rod crosshead. Since the wheels were all firmly in place and there being no way to drive a lubricator from the valve gear without it looking a right mess a split eccentric it had to be. Making and fitting such an eccentric to the axle was not that difficult but did need some careful marking out and machining. To allow for the two parts of the eccentric to be faced off, bolted together and the whole machined circular to take the eccentric strap a quite large lump of cast iron was called for, something over two inches in diameter. I am now working on the eccentric rod and its bearing supports and fiddling with the lubricator to get its position right as there are a number of obstacles in the way. The lubricator will be hidden under the locomotive front valance.
